**CASE STUDY  
SERVICE: COATING**

**CUSTOMER: WBPDCCL-BKTPP**

**EQUIPMENT: COATING OF Y PIECE OF COAL MILL**

## **Y-PIECE OF COAL MILL**

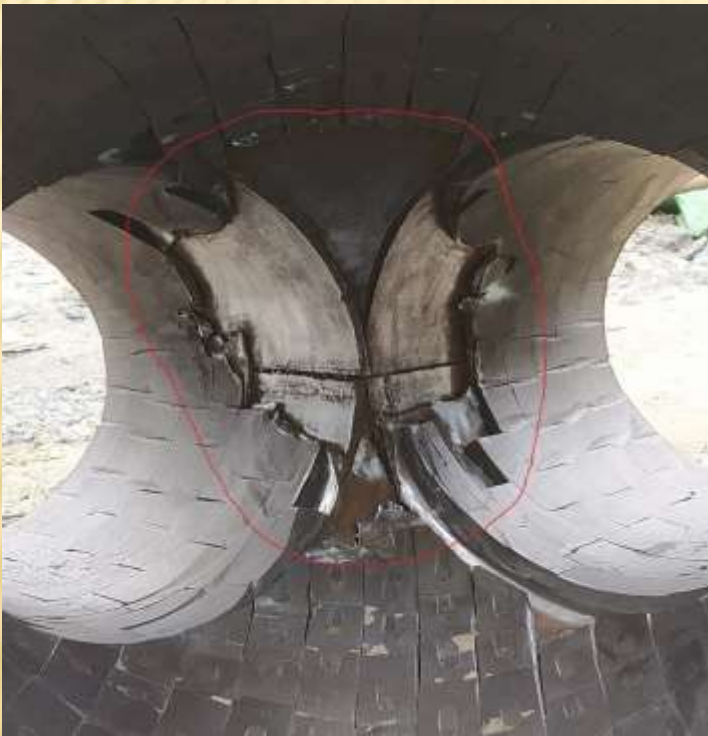
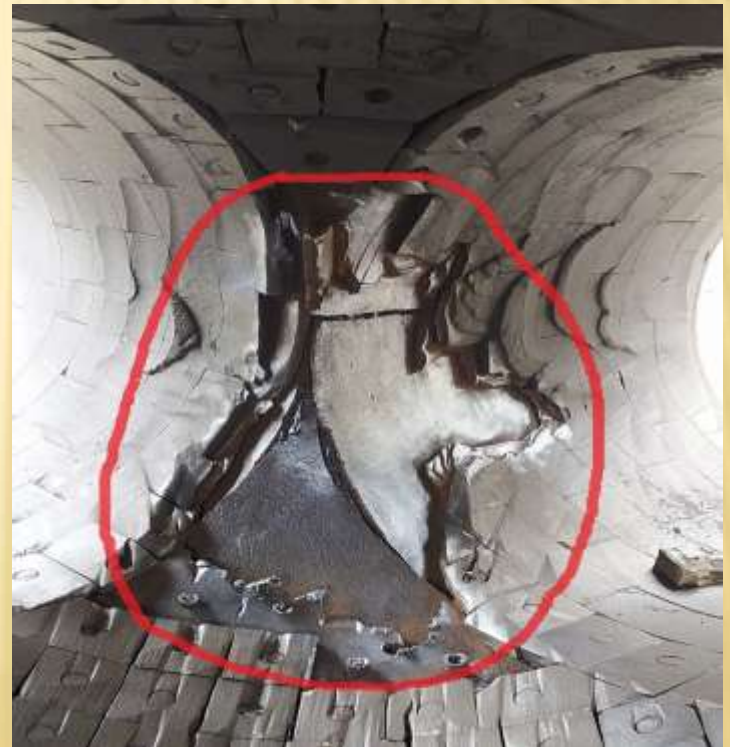
# BEFORE APPLICATION

**In a 210 MW thermal power station, the Y-piece is getting eroded very quickly due to coal dust in the coal mill area. This erosion was repaired by Duromar Erosion Protection Coating.**

Eroded Y-Piece of Coal Mill due to Coal Dust
